Characterization of Fatigue Damage for Bonded Composite Skin/Stringer Configurations

NASA/TM-2008-215308

The fatigue damage was characterized in specimens which consisted of a tapered composite flange, representing a stringer or frame, bonded onto a composite skin. Quasi-static tension tests were performed first to determine the failure load. Subsequently, tension fatigue tests were performed at 40%, 50%, 60% and 70% of the failure load to evaluate the debonding mechanisms between the skin and the bonded stringer. For four specimens, the cycling loading was stopped at intervals and the specimens were taken out of the grips. Photographs of the polished specimen edges were taken under a light microscope to document the occurrence and growth of matrix crack and delaminations. At two diagonally opposite corners of the flange, a delamination appeared to initiate at the flange tip from a matrix crack in the top 45° skin ply and propagated at the top 45°/-45° skin ply interface. At the other two diagonally opposite corners, a delamination running in the bondline initiated from a matrix crack in the adhesive pocket. Dye penetrant X-ray radiography was also used to measure the amount of d

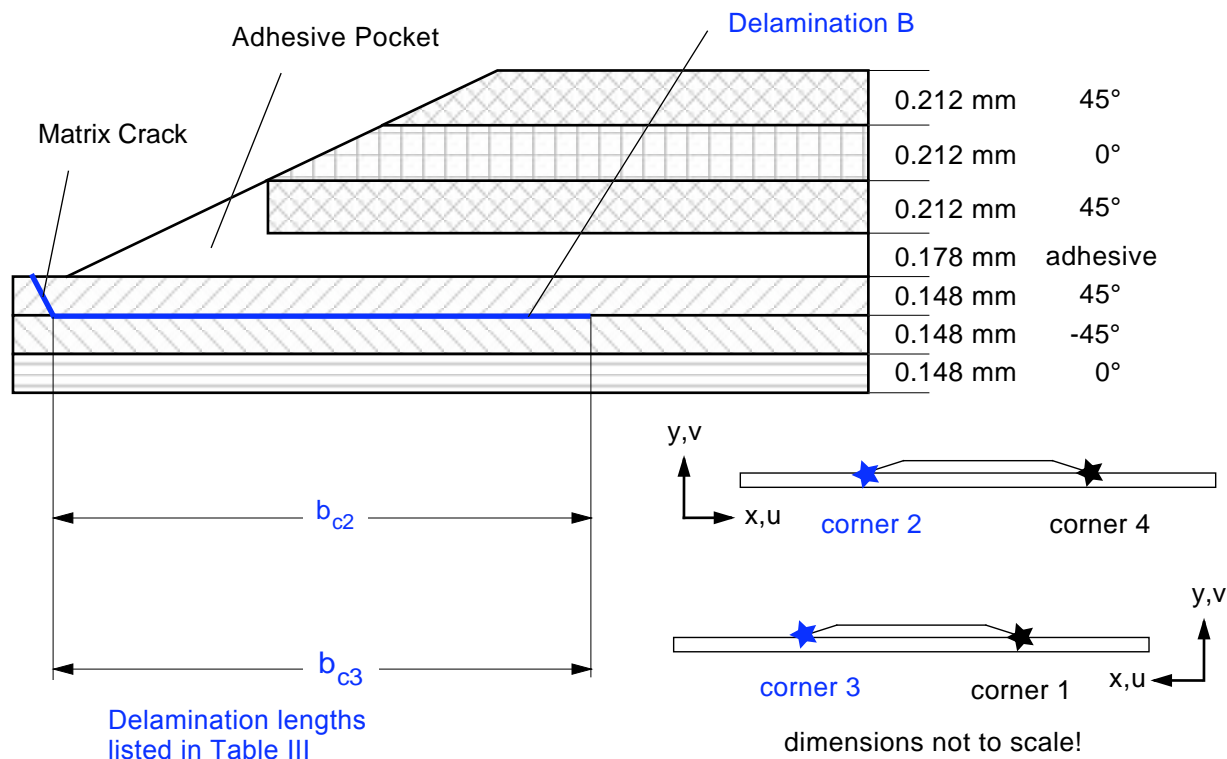
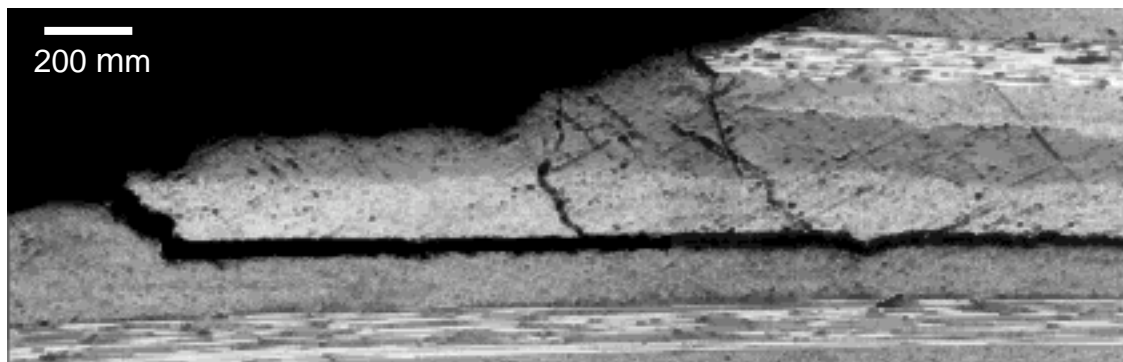
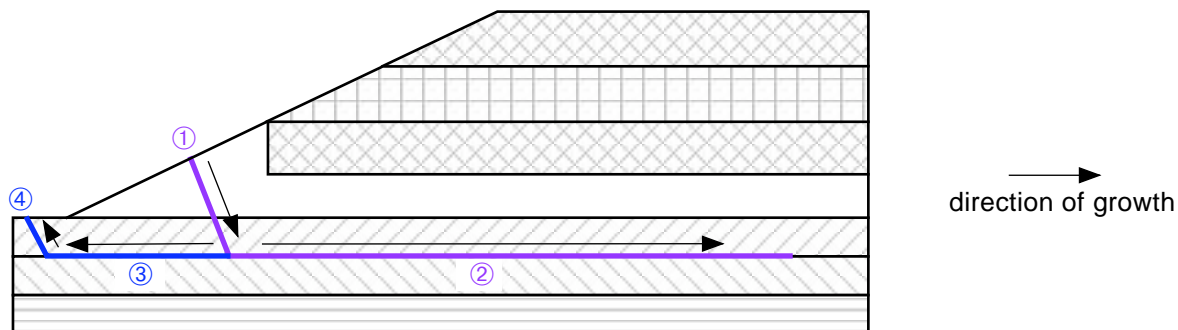
Figure 14. Typical damage patterns observed in skin/stringer specimen at specimen corners 2 and 3 [7].

At corners 2 and 3, a delamination (B, in blue) formed in the top $45^\circ/-45^\circ$ skin ply interface, as depicted in Figure 14. For the quasi-static case, the damage can only be observed after the test, and it appears that this delamination initiated at the flange tip from a matrix crack in the top 45° skin ply as shown in Figure 14(a,b). In fatigue, the sequence of events, as depicted in Figure 14(c), has been observed with a *Questar*[®] microscope. The first matrix crack occurs in the adhesive pocket (①), then grows through the top 45° skin ply and forms a delamination B (② in violet) in the top $45^\circ/-45^\circ$ skin ply interface growing towards the center of the flange (①→②). Sometimes, the delamination B (③, in blue) grows back towards the grip and causes a matrix crack through the top 45° ply, reaching the skin surface (③→④). The original matrix crack through the adhesive pocket and top 45° ply closes (①). The closure explains the observations from the static case, where the matrix crack through the adhesive pocket was not observed (see Figure 14(a)).

In fatigue, damage first appeared at corner 2 and 3 (delamination B) for 12 of the 14 specimens. The delamination lengths were measured using the traveling stage of the optical microscope while the edges were still covered with white paint. The lengths measured for four specimens (9B-02, 7B-06, 8B-06 and 10B-03) after different numbers of load cycles are listed in Table III. The mechanics are discussed in the section on the mechanics of failure.

- At corners 2 and 3, a delamination initiated at the flange tip from a matrix crack in the top 45° skin ply and propagated in the top 45°/-45° skin ply interface. In fatigue, damage first appeared at this location for 12 of the 14 specimens.

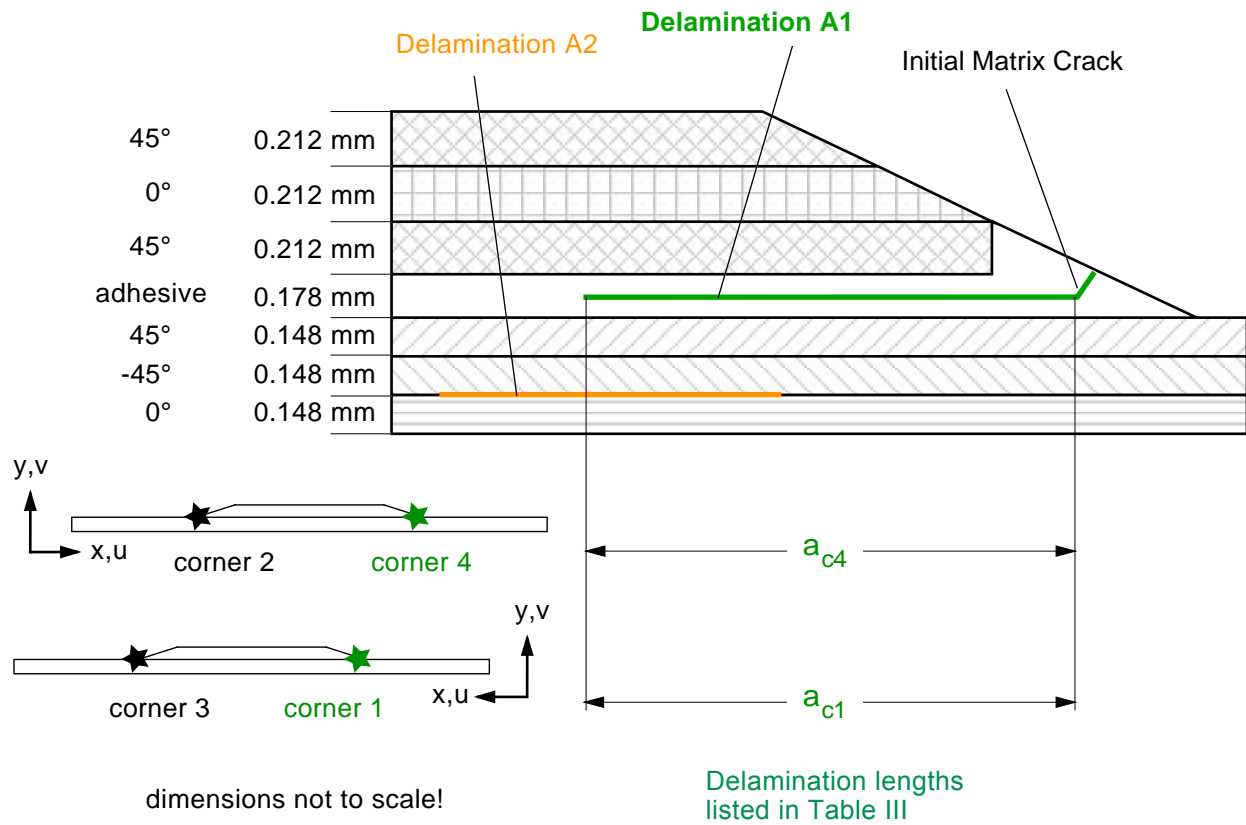
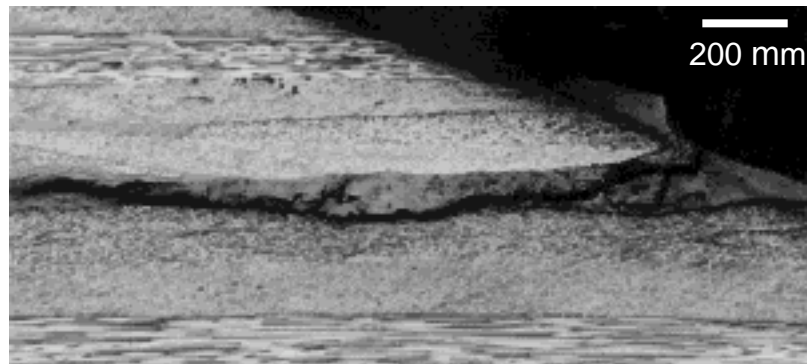
Figure 15. Typical damage patterns observed in skin/stringer specimen at specimen corners 1 and 4 [7].

At corners 1 and 4, a delamination running in the bondline (A1, in green) initiated from a matrix crack in the adhesive pocket, as shown in Figure 15. In some of the quasi-static cases, a second delamination (A2, in orange) was observed below the first one, in the top $-45^\circ/0^\circ$ skin ply interface. Delamination A2 was not observed in fatigue presumably, because the load levels were lower compared to the static test.

- At corners 1 and 4, a delamination running in the bondline initiated from a matrix crack in the adhesive pocket.
- The micrographs taken from individual slices reveal a more complex pattern inside the specimen. The two delamination patterns observed at the edges are present simultaneously across most of the width of the specimen.

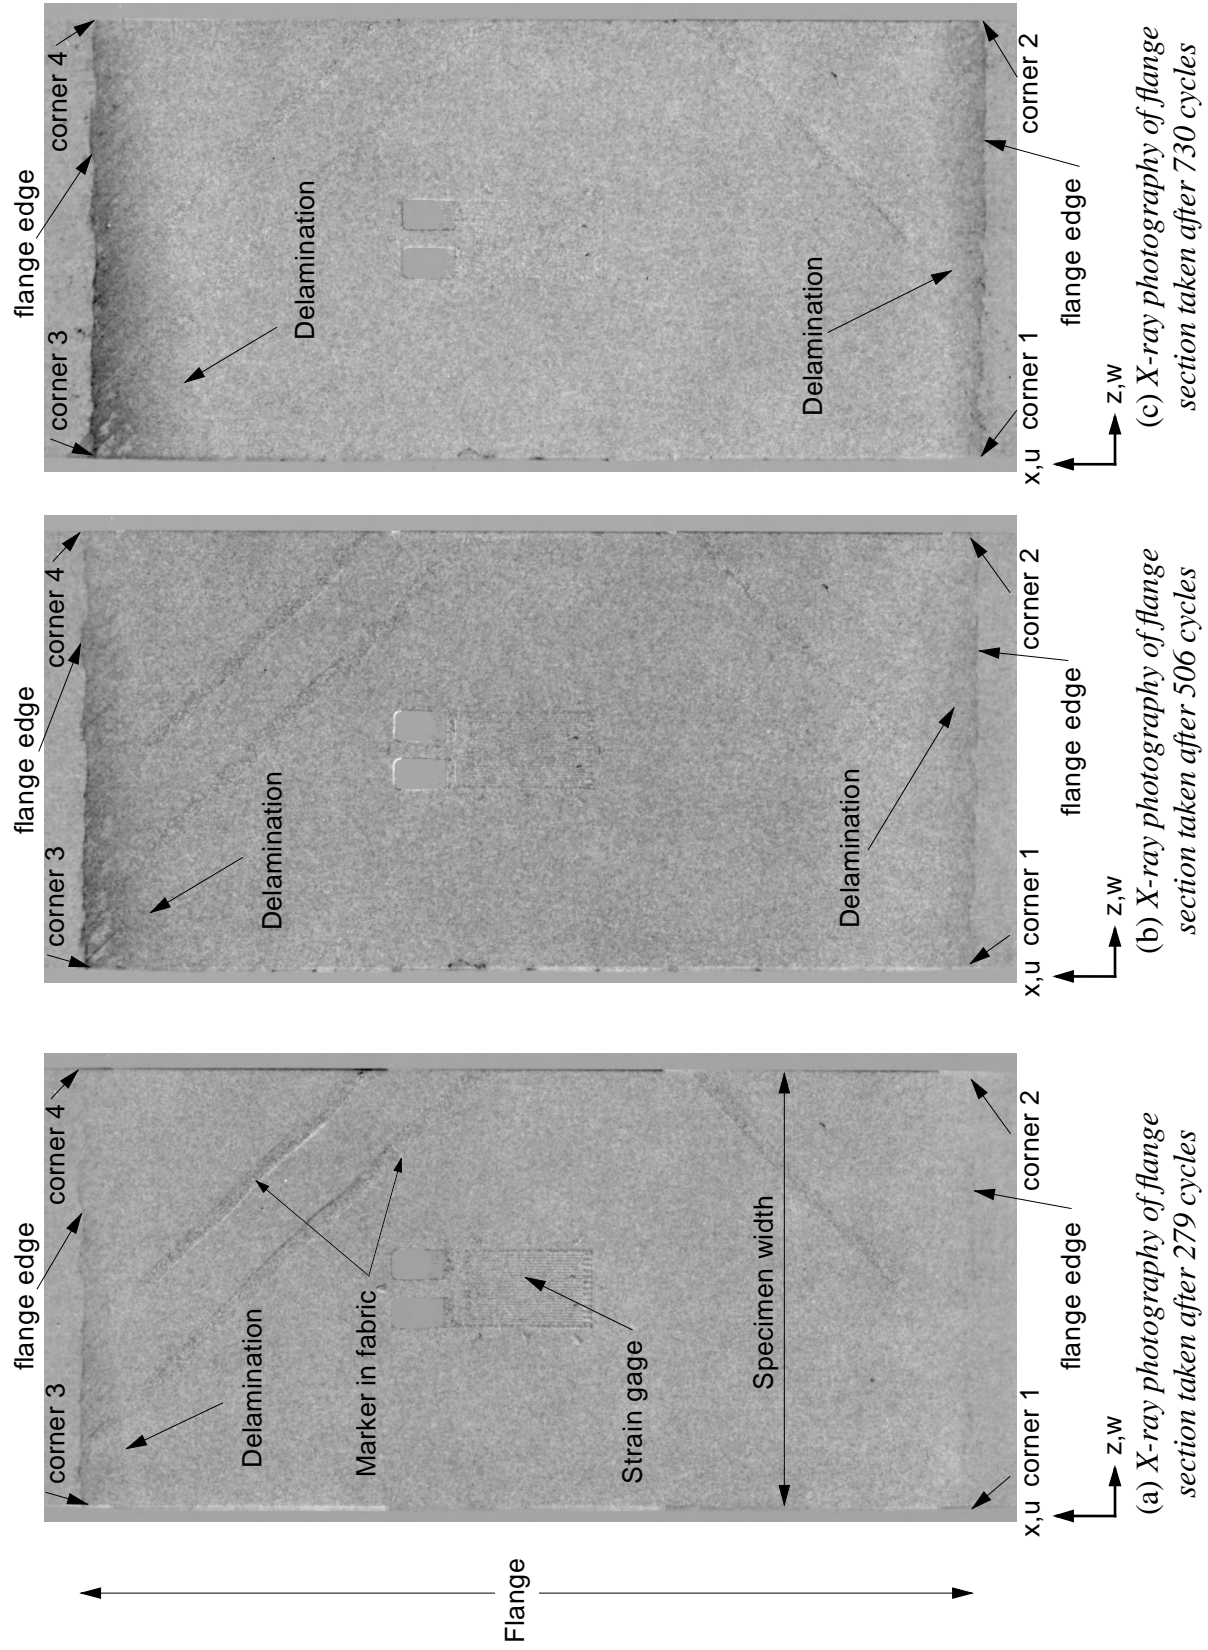
Figure 16. Damage progression in skin/stringer debond specimen 8B-06.

The final images obtained from X-ray radiography and image post-processing are shown in Figures 16 to 19 for four specimens (9B-02, 7B-06, 8B-06 and 10B-03) after different load cycles. The dark areas where the contrast fluid had penetrated into the damaged section of the specimen reveal the delaminations. In the image of Figure 16(a) - taken from specimen 8B-06 after 279 cycles, a delamination was only visible along the flange edge from corners 3 to 4. The gray intensity appeared to be more pronounced towards corner 3 (delamination B), which suggests an increased growth in this area. This observation is confirmed by Figure 16(b) (taken after 506 cycles) and Figure 16(c) (taken after 730 cycles) where the delamination appears to have grown further to corner 3 (delamination B). Delamination growth at the opposite flange edge (from corner 1 to 2) was also observed as shown in Figures 16(b) and (c). The growth appeared to be slower

and more uniform compared to the other edge. The observations were verified by cutting the specimens into slices as shown in Figures 6 and 7. Micrographs of the edges were obtained to reveal the growth in the interior of the specimen. The observations are discussed later.

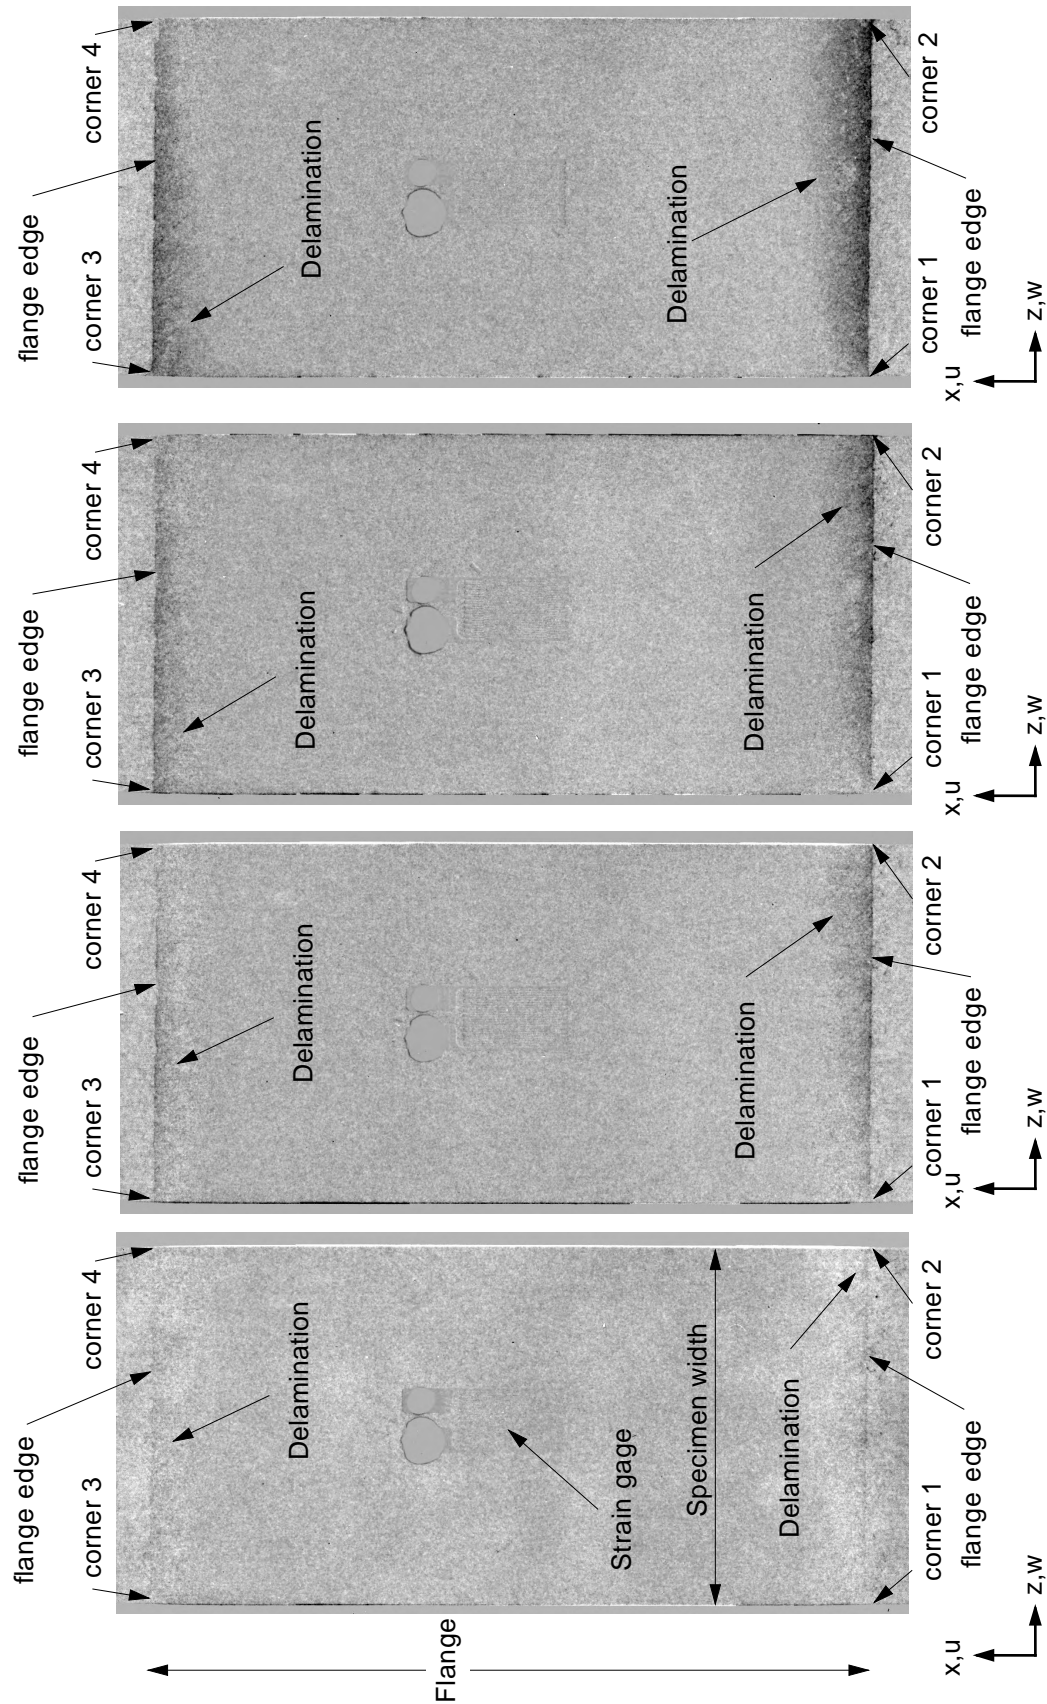
Figure 17. Damage progression in skin/stringer debond specimen 10B-03.

The images for the other specimens (10B-03, 9B-02 and 7B-06) reveal a similar growth pattern as shown in Figures 17, 18 and 19. For specimen 10B-03, shown in Figure 17, the observations were also verified by slicing the specimens as shown in Figures 6 and 7. The observations from micrographs of the edges are discussed later. For specimen 10B-03, shown in Figure 18, the gray intensity is less pronounced which made it more difficult to determine how far the contrast fluid had penetrated into the damaged section. For specimen 7B-06, the delamination lengths measured at the polished edges of corners 1 to 4 were added to Figure 19. The measured lengths are listed in Table III.

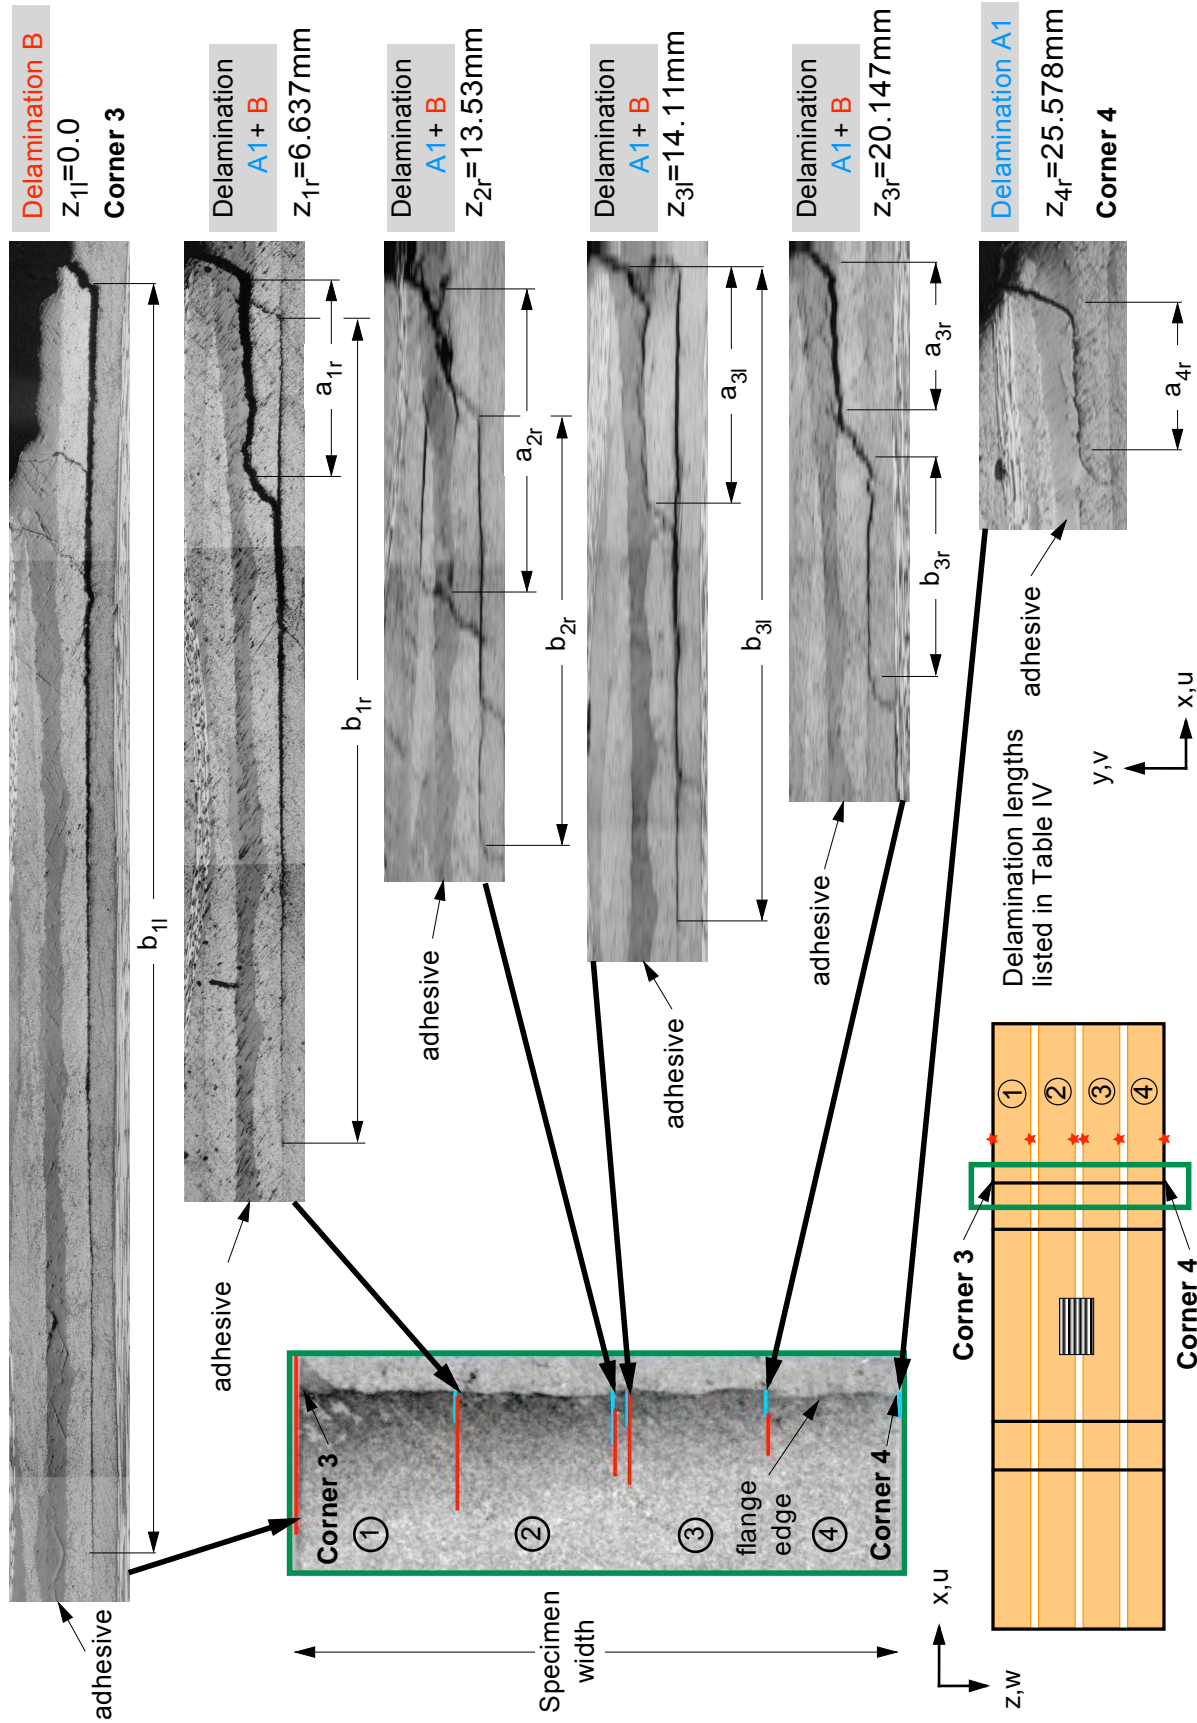
Figure 20. Micrographs of interior sections along flange edge from corners 3 to 4 (specimen 8B-06).

Two specimens (8B-06 and 10B-03) were cut into slices as discussed earlier. The slices are shown in Figures 6 and 7. The edges marked with a red star in Figure 6 were polished and micrographs were obtained to reveal the growth in the interior of the specimen. The micrographs taken across the width of specimen 8B-06 along the flange edge from corners 3 to 4 were assembled as shown in Figure 20. A detail of an x-ray radiograph (taken from Figure 16c) and a sketch of the slices (taken from Figure 6a) were included to help identify the location of the micrographs with respect to the specimen width. At the specimen edges (corners 3, $z_{11}=0.0$ mm and 4, $z_{4r}=25.578$ mm), only one delamination type (B, in red or A1, in light blue) was observed as discussed earlier and shown in Figures 14 and 15. Based on the observations at the edges of the specimen, a simple transition from delamination type B to type A1 was expected to occur in the interior of the specimen. The micrographs, however, reveal a more complex pattern where both delaminations (B and A1) are present simultaneously across most of the width of the specimen. The mechanics of the failure are discussed below. The delamination lengths were measured using image analysis of the scanned and stitched micrographs. The delamination lengths are listed in Table IV. The delamination outline seen in the X-ray image (dark area) captured the size of the delamination well, which is shown by adding delamination lengths (B, in red or A1, in light blue) measured from the micrographs. The images obtained from X-ray radiography, however, were not able to reveal the complexity of the damage pattern observed. An ultrasound inspection, which includes a D-scan, time-of-flight scan or depth scan may be required to identify the complete pattern.

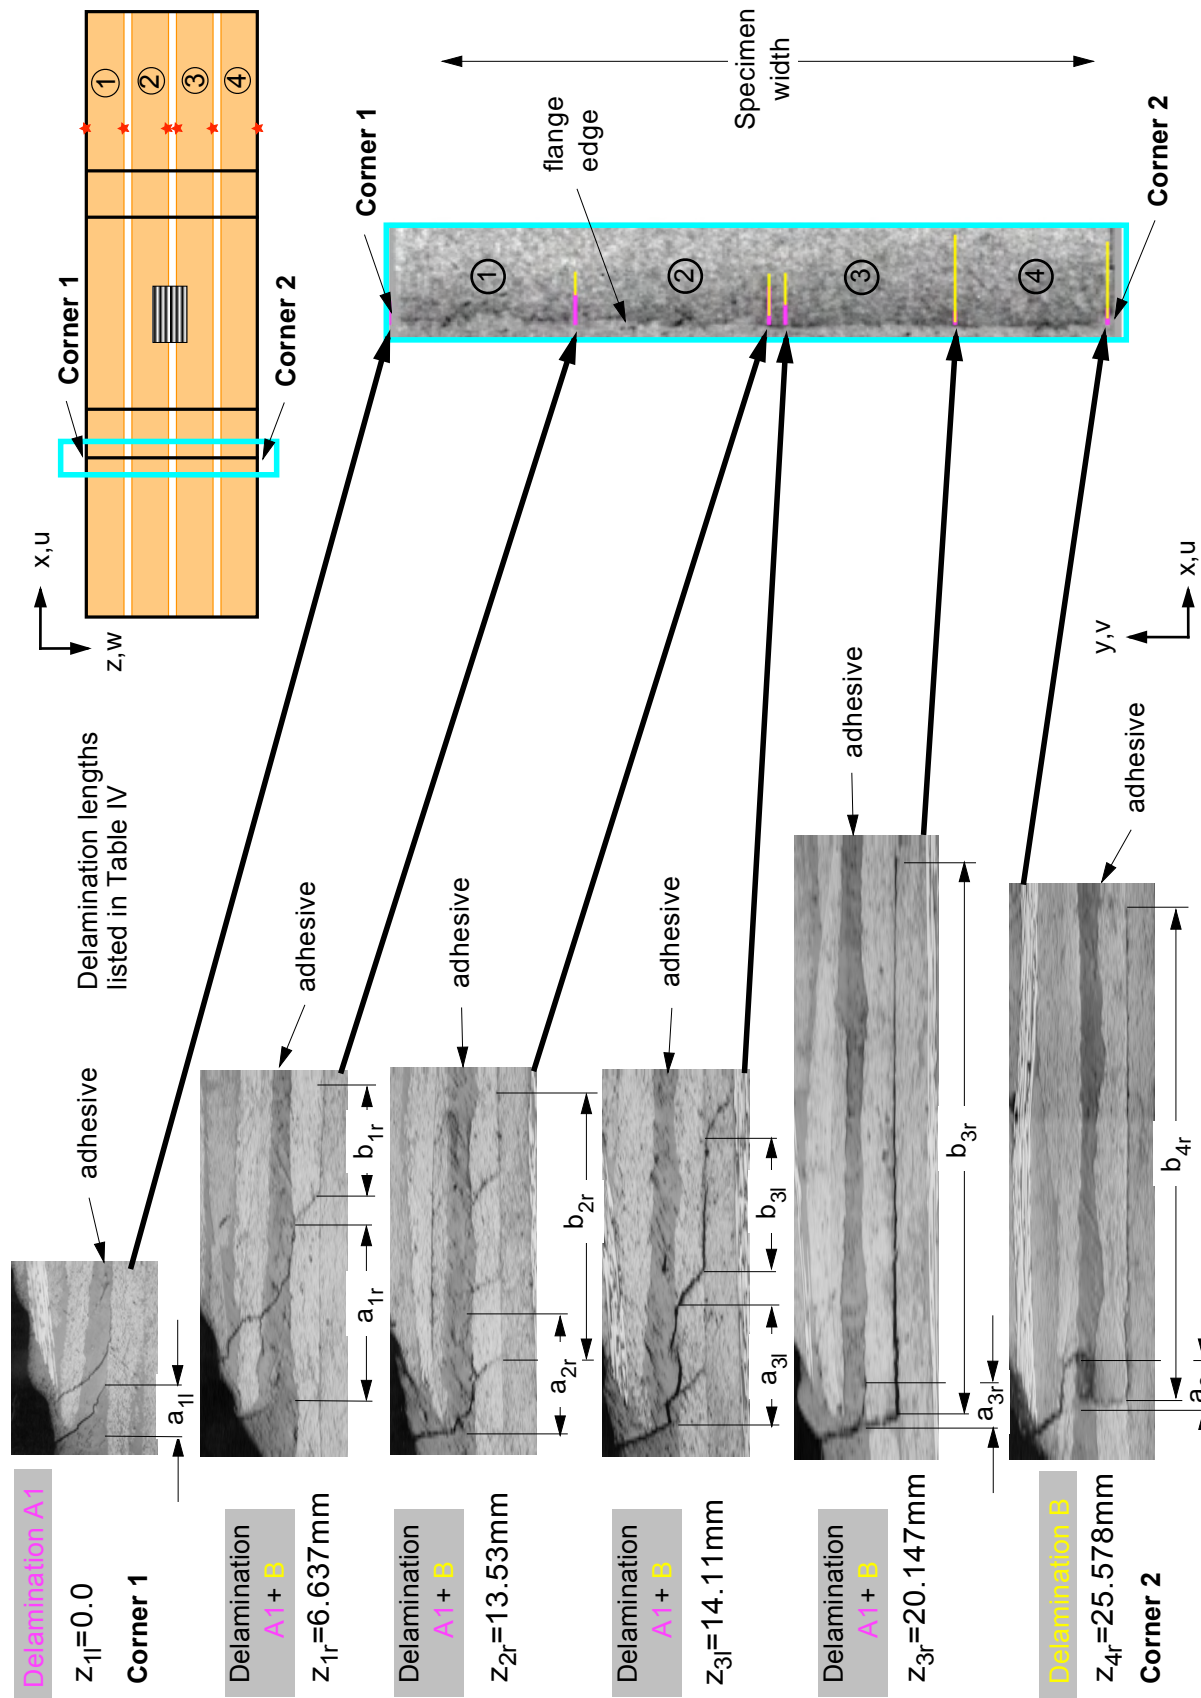
Figure 21. Micrographs of interior sections along flange edge from corners 1 to 2 (specimen 8B-06).

The micrographs taken across the width of specimen 8B-06 along the opposite flange edge from corners 1 to 2 were assembled in a similar manner as shown in Figure 21. As above, a detail of an x-ray radiograph and a sketch of the slices were included to help identify the location of the micrographs with respect to the specimen width. The same complex pattern as discussed above is observed where both delaminations (B, in yellow and A1, in magenta) are present simultaneously across most of the width of the specimen. In this particular case, delamination A1 is visible across the entire width of the specimen including the free surface at corner 2 ($z_{4r}=25.578$ mm). The delamination lengths measured from the individual micrographs are listed in Table IV. The lengths listed in Table III and Table IV for the same corners differ slightly, since they were measured at

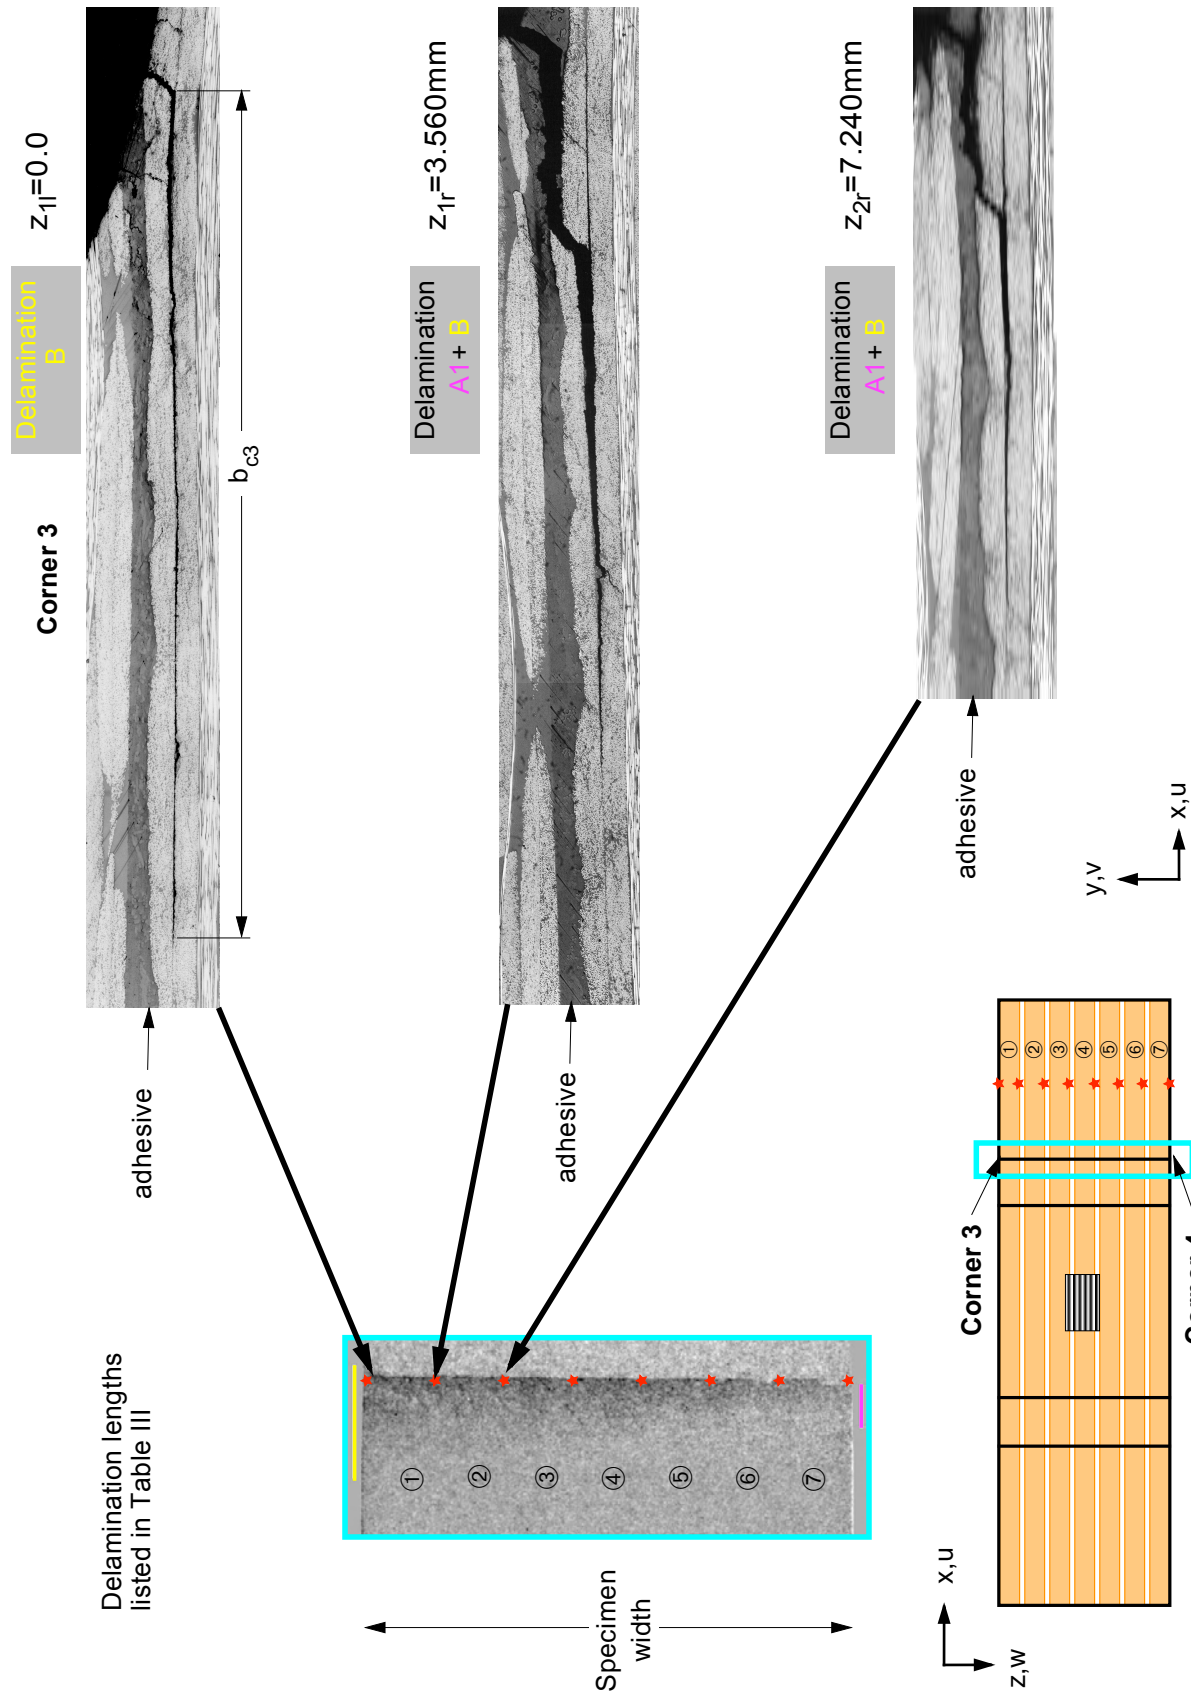
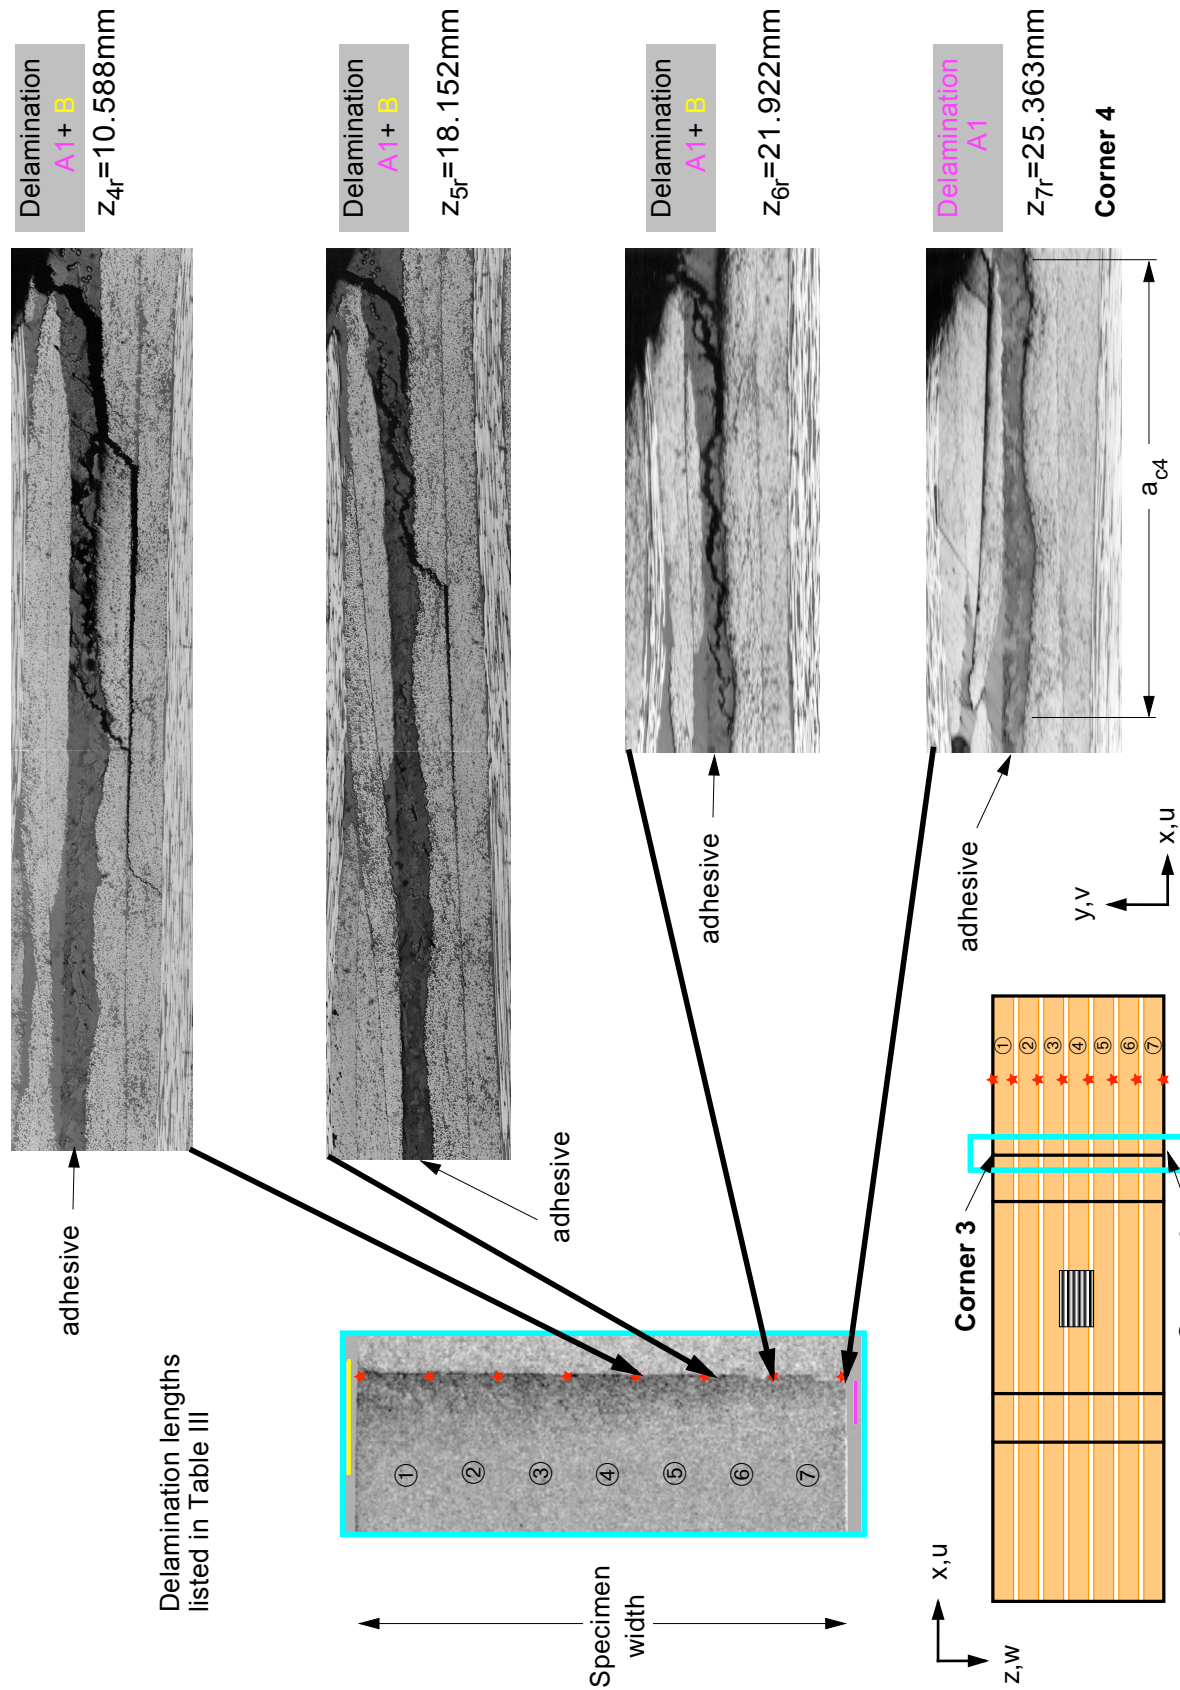
Figure 22a. Micrographs of interior sections along flange edge from corners 3 to 4 (specimen 10B-03).

The micrographs taken across the width of specimen 10B-03 along the flange edge from corners 3 to 4 were assembled as discussed above and are shown in Figures 22a and b. A detail of an x-ray radiograph (taken from Figure 17d) and a sketch of the slices (taken from Figure 6b) were included to help identify the location of the micrographs with respect to the specimen width. The same complex pattern as discussed above for specimen 8B-06 is observed here, and both delaminations (B, in yellow and A1, in magenta) are present simultaneously across most of the width of the specimen. The delamination lengths measured at the edges are listed in Table III.

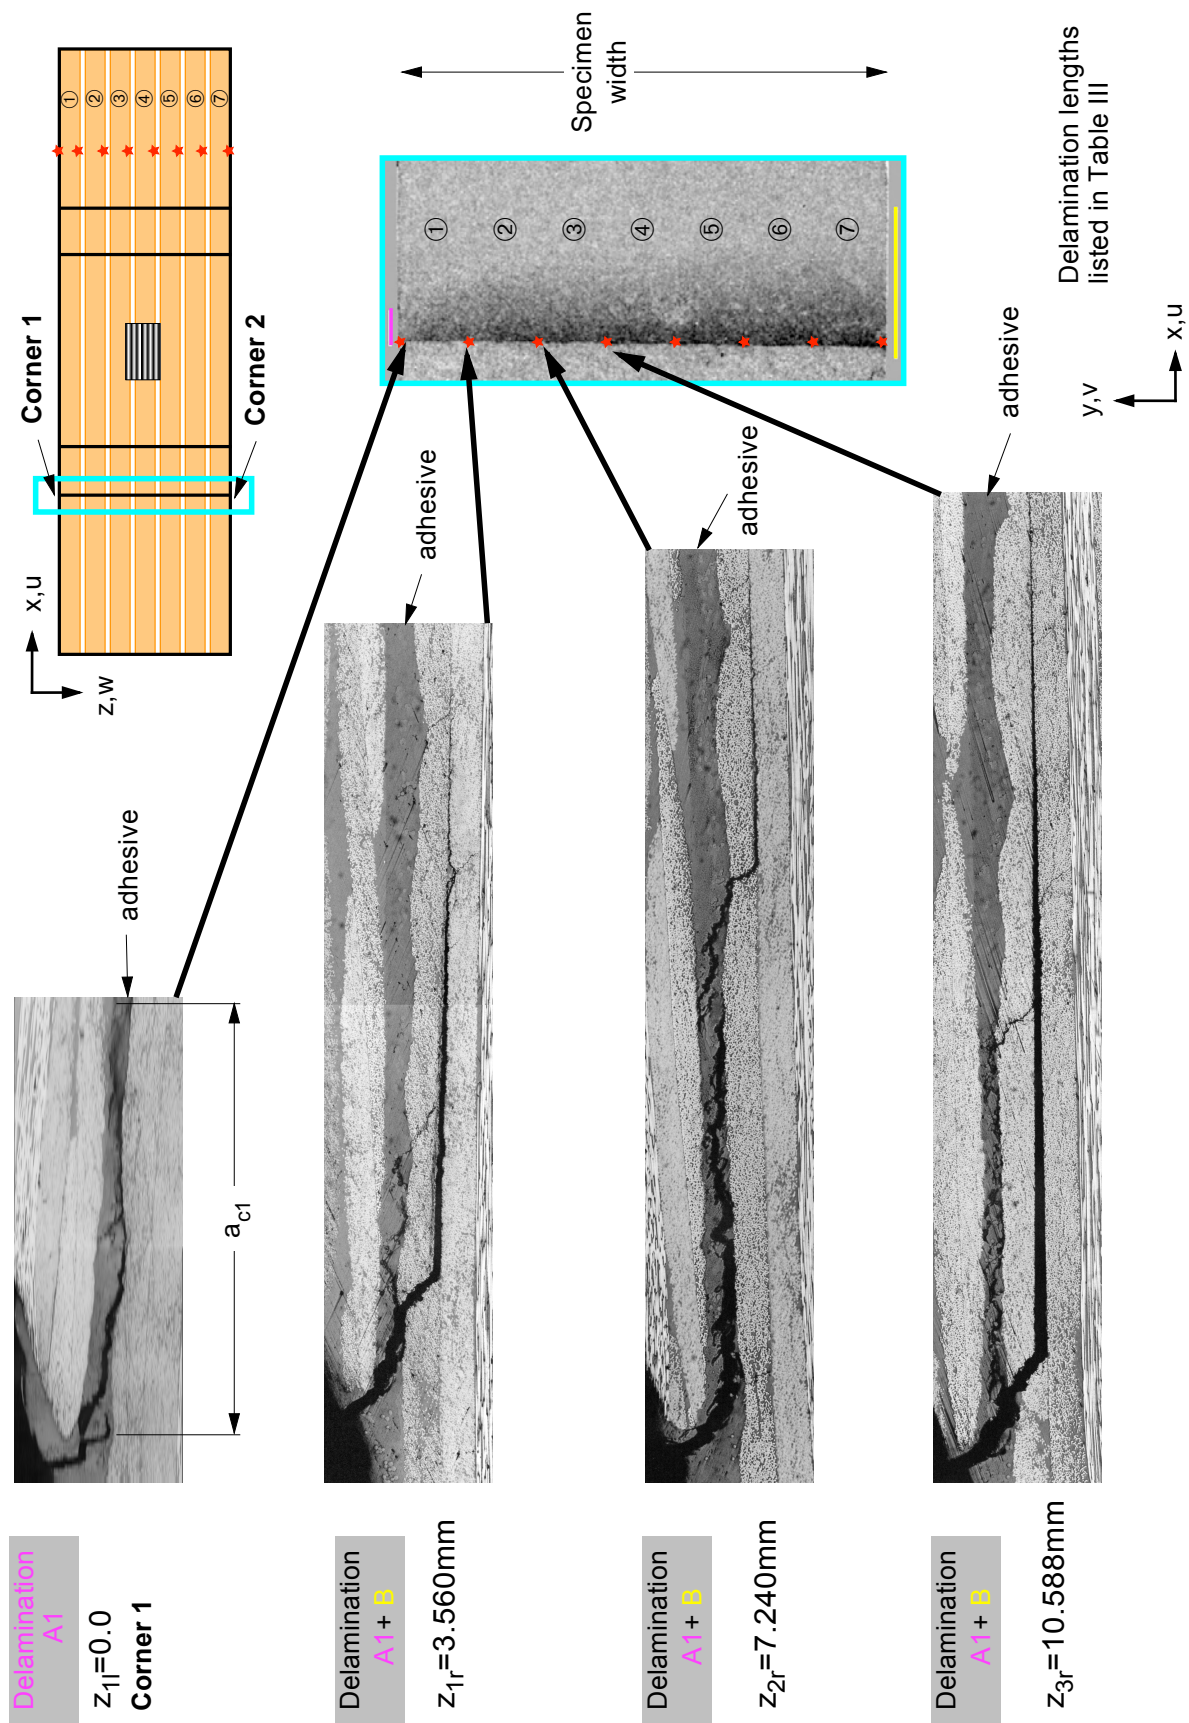
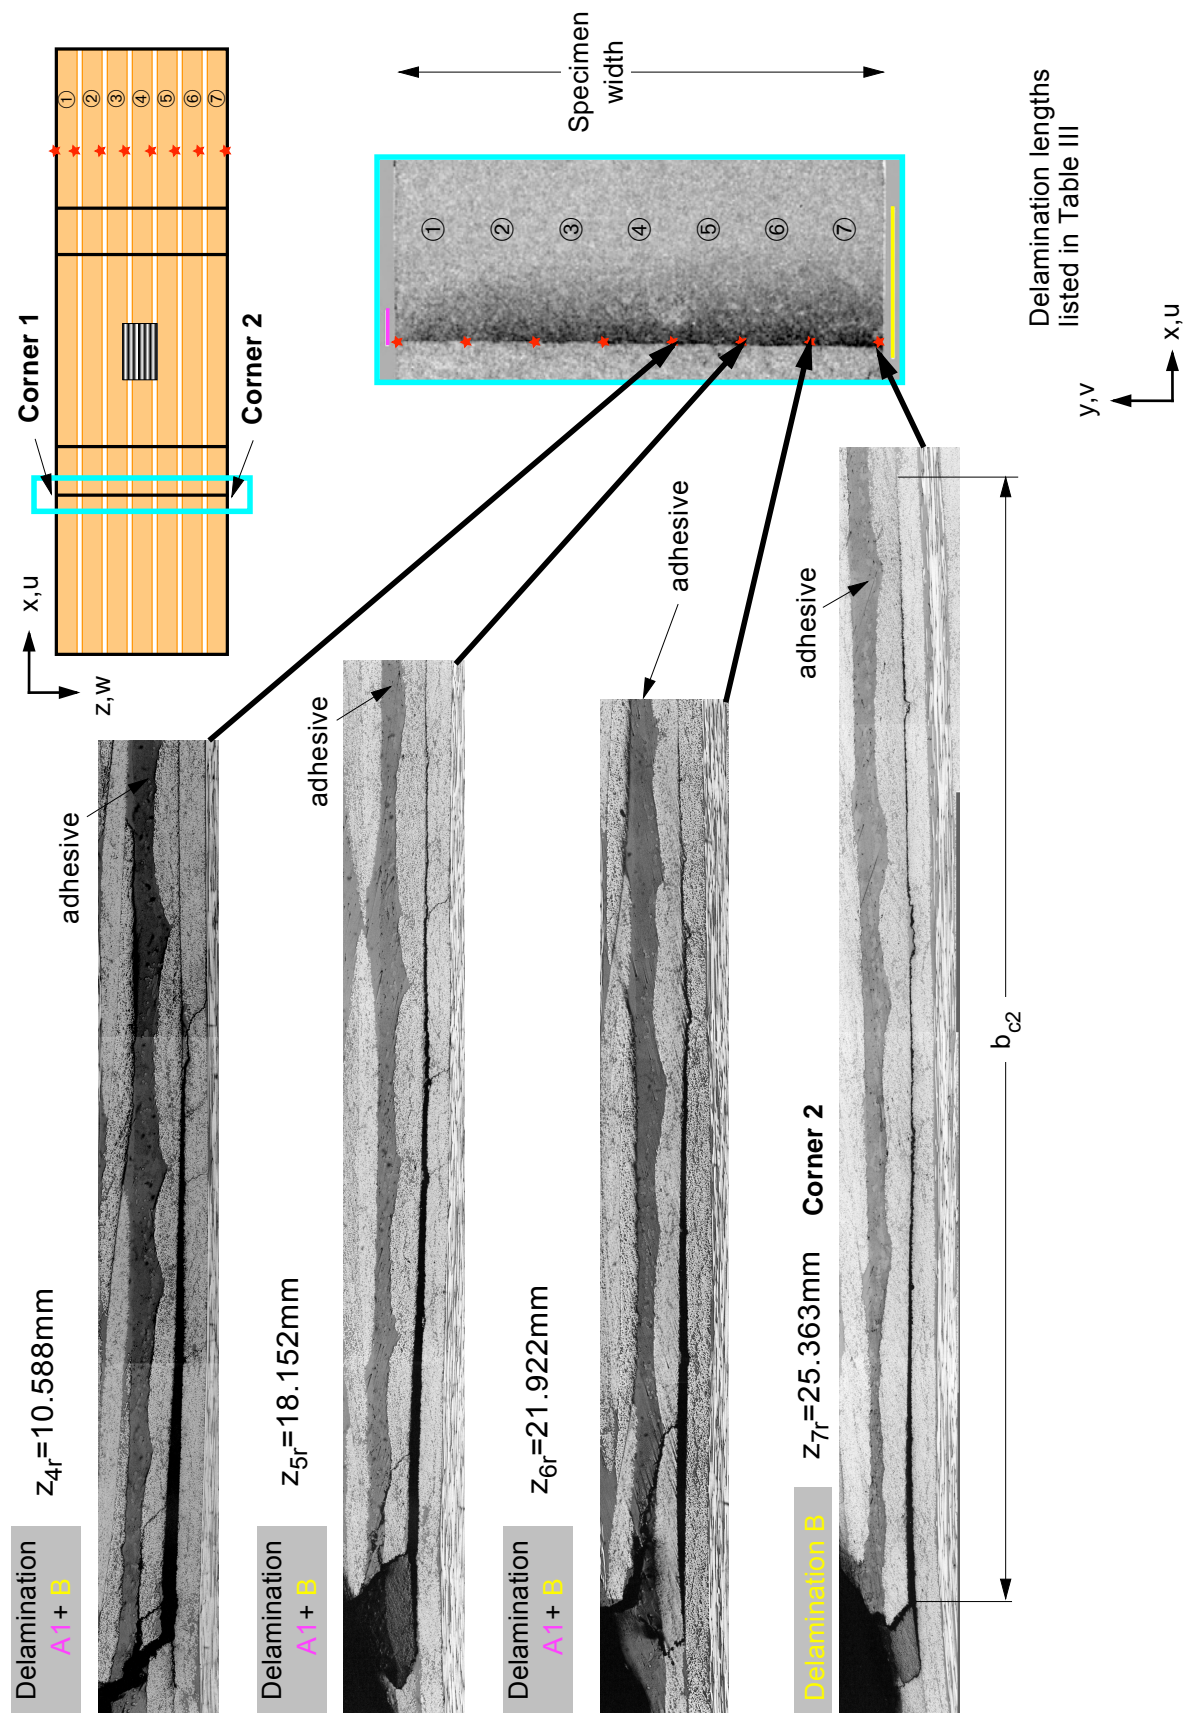
Figure 23a. Micrographs of interior sections along flange edge from corners 1 to 2 (specimen 10B-03).

The assembly of the corresponding micrographs taken across the width of the specimen along the opposite flange edge from corners 1 to 2 is shown in Figures 23a and b. The same complex pattern as discussed above is observed here, and both delaminations (B, in yellow and A1, in magenta) are present simultaneously across most of the width of the specimen.
